SUBJECT: Evaluation of Coated Test Panels after Accelerated Weathering Exposure; KTA-Tator Inc. Project No. 66077381

In accordance with KTA-Tator, Inc. (KTA) Proposal Number QN5160 dated February 27, 2025, KTA has performed laboratory accelerated weathering exposures and testing of six submitted coated test. This report contains descriptions of the testing procedures employed and the results of the testing performed.

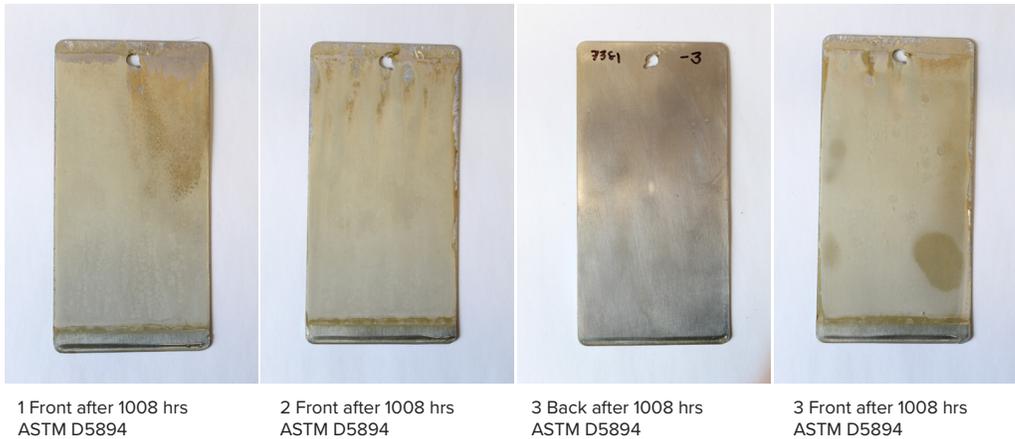
KTA ID #	Panel Type	ASTM D714 Blistering Rating	ASTM D610 Rusting Rating	Coating Delamination Observations	Coating Discoloration Observations
66077381-1	Aluminum	10	10	Delamination along top edge where panel rested against panel rack in QUV cabinet, and along side edges.	Coating became opaque and beige in color on upper half of panel, fading back to clear in lower half.
66077381-2	Aluminum	10	10	Delamination along top edge where panel rested against panel rack in QUV cabinet, and along side edges.	Coating became opaque and beige in color on upper half of panel, fading back to clear in lower half.
66077381-3	Aluminum	10	10	Delamination along top edge where panel rested against panel rack in QUV cabinet, and along side edges.	Coating became opaque and beige in color on upper half of panel, fading back to clear in lower half, with several darker spots.
66077381-4	Copper	10	10	Delaminated spots near top and along side edges.	Coating became opaque and beige, slightly darker in color on upper half of panel. Green oxidation evident at top edge. Delaminated spots were dark in color.

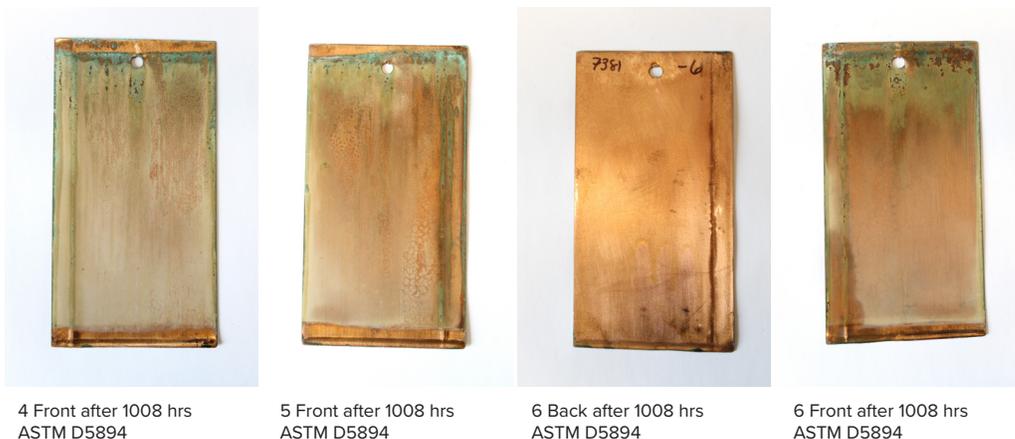
66077381-5	Copper	10	10	Delaminated spots near top and along side edges.	Coating became opaque and beige, slightly darker in color on upper half of panel. Green oxidation evident at top edge and strip running down right side. Delaminated spots were dark in color.
66077381-6	Copper	10	10	Delaminated spots near top and along side edges.	Coating became opaque and beige, slightly darker in color on upper half of panel. Green oxidation evident at top edge and strip running down left side. Delaminated spots were dark in color.
